EXPERIMENTAL INVESTIGATION OF AIR-COOLED TURBINE BLADES
IN TURBOJET ENGINE

XIII - ENDURANCE EVALUATION OF SEVERAL PROTECTIVE
COATINGS APPLIED TO TURBINE BLADES OF
NONSTRATEGIC STEELS

July 16, 1953

6817
NACA RM E53E18

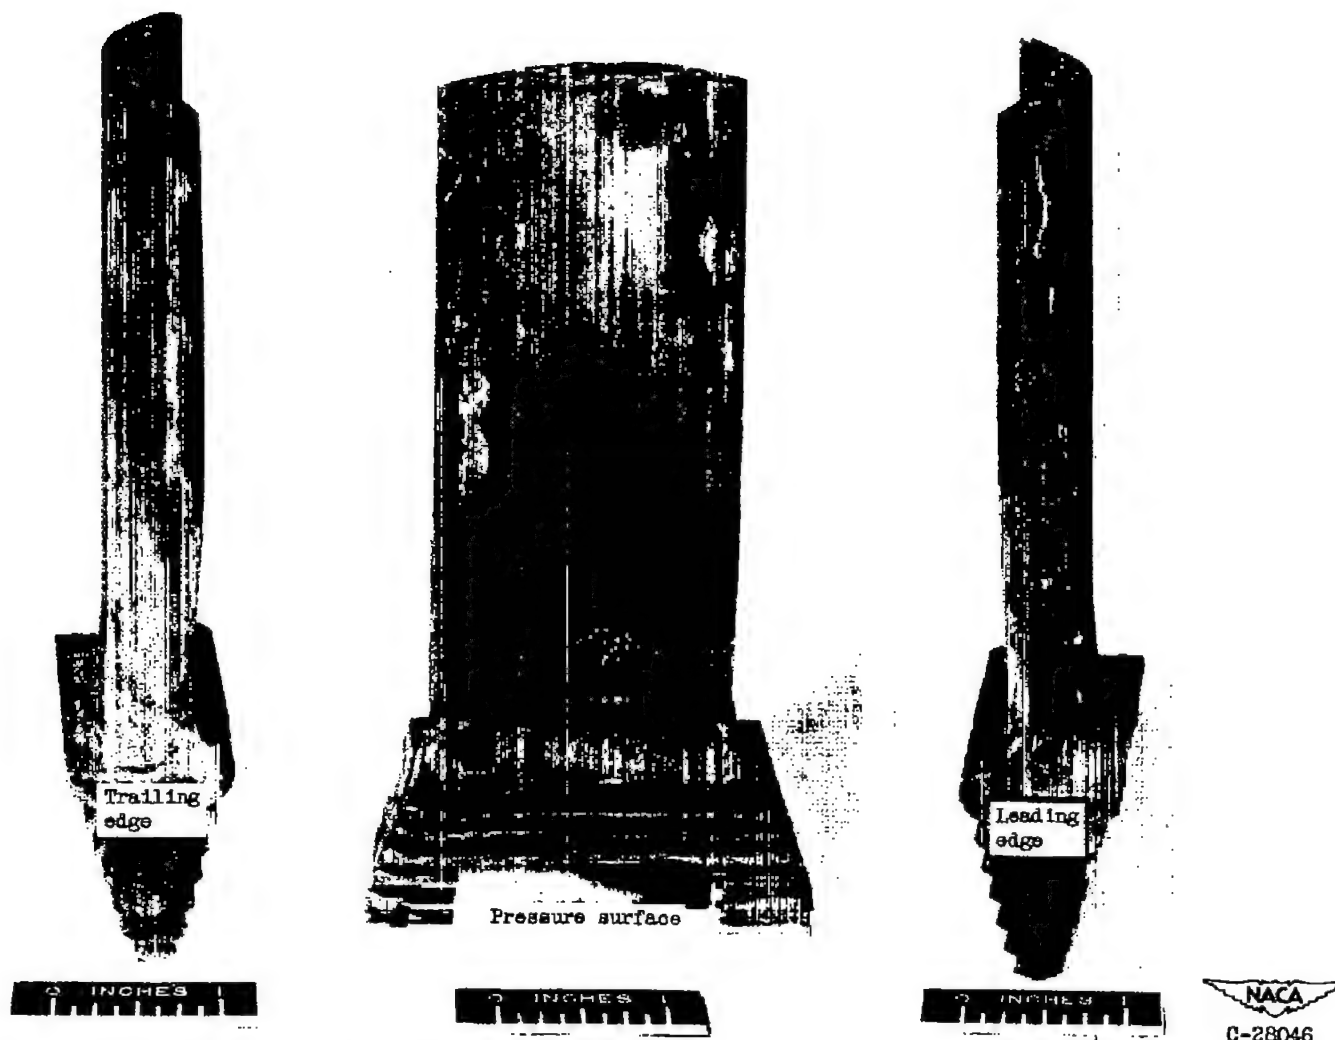
Blade 1. - The coating on blade 1 was considered a failure after 7.3 hours of rated engine speed operation, and investigation of the blade was concluded at the end of that time. Figure 3(a) shows several views of the blade at the conclusion of the tests and it can be seen that the coating chipped away from the leading- and trailing-edge regions of the blade. There is also an area near the root in the midchord region of

the blade where the coating flaked off. The failure of the coating apparently was a function of the metal temperature, as the greatest damage to the coating occurred at the leading- and trailing-edge regions where the metal temperatures are the highest (see fig. 2). More coating was removed from the leading edge than from the trailing edge, probably because the high-velocity combustion gases impinge directly upon the leading edge and their erosive action is greatest in this area.

(a) Blade 1 after 7.3 hours (20 cycles plus 2.3 hours at rated test conditions) with coolant-flow ratio of 0.048. Complete breakdown of coating along leading and trailing edges evident.

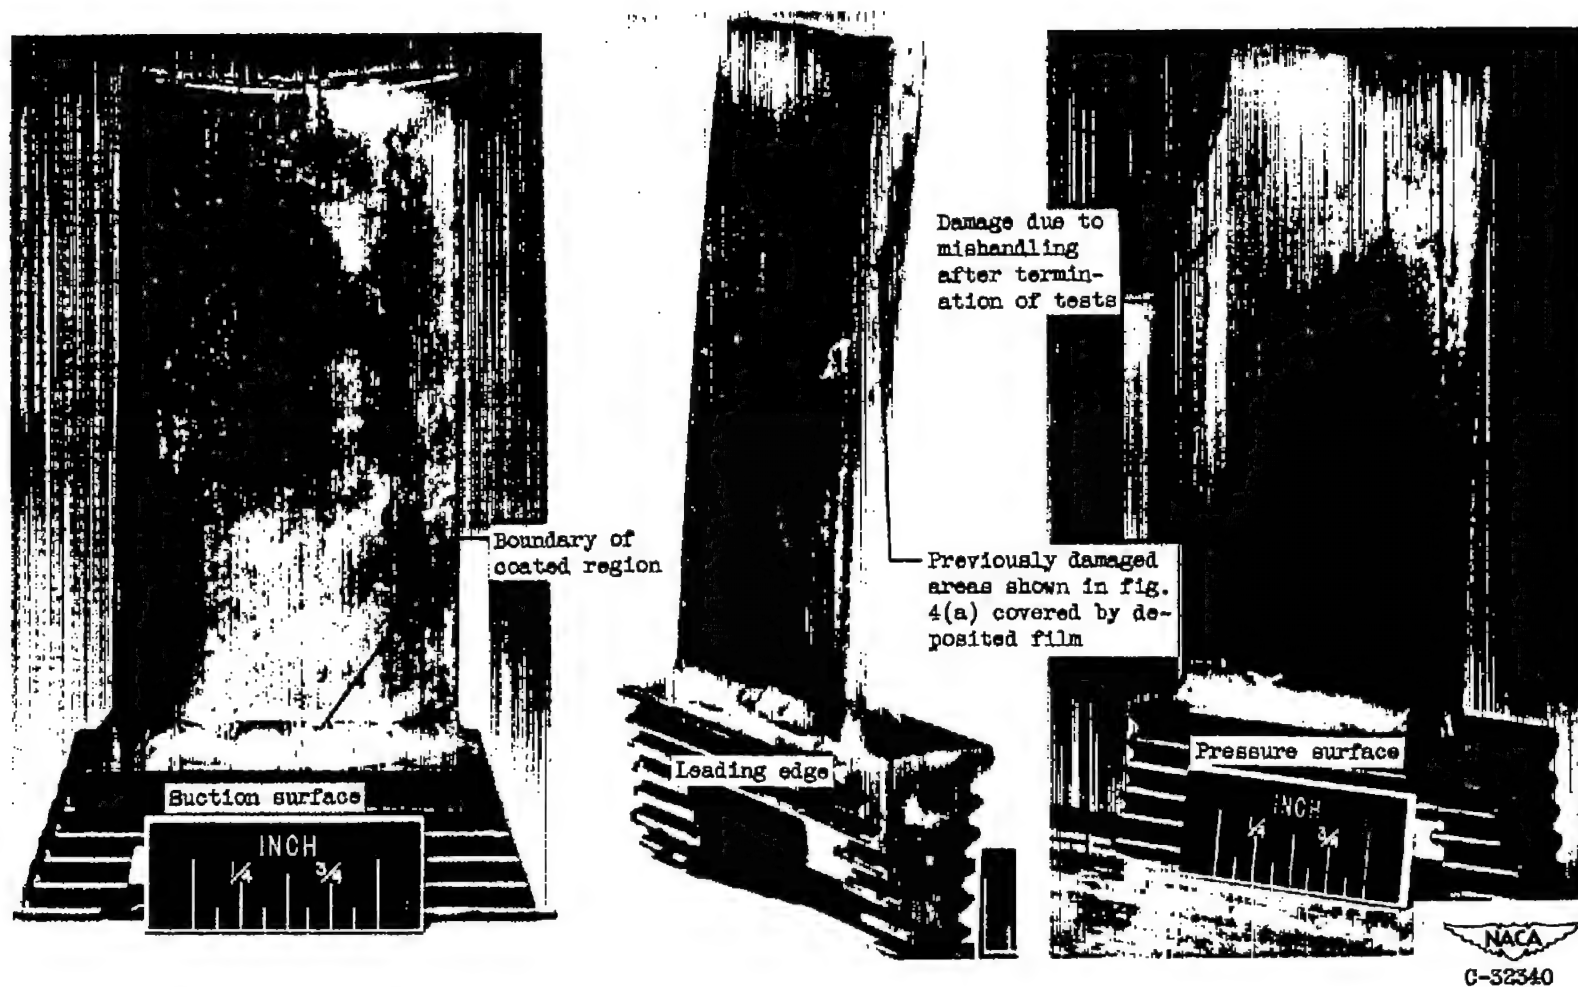
(b) Blade 5 after 100 hours at rated test conditions with coolant-flow ratio of 0.048. Coating in excellent condition except where hit by foreign objects.

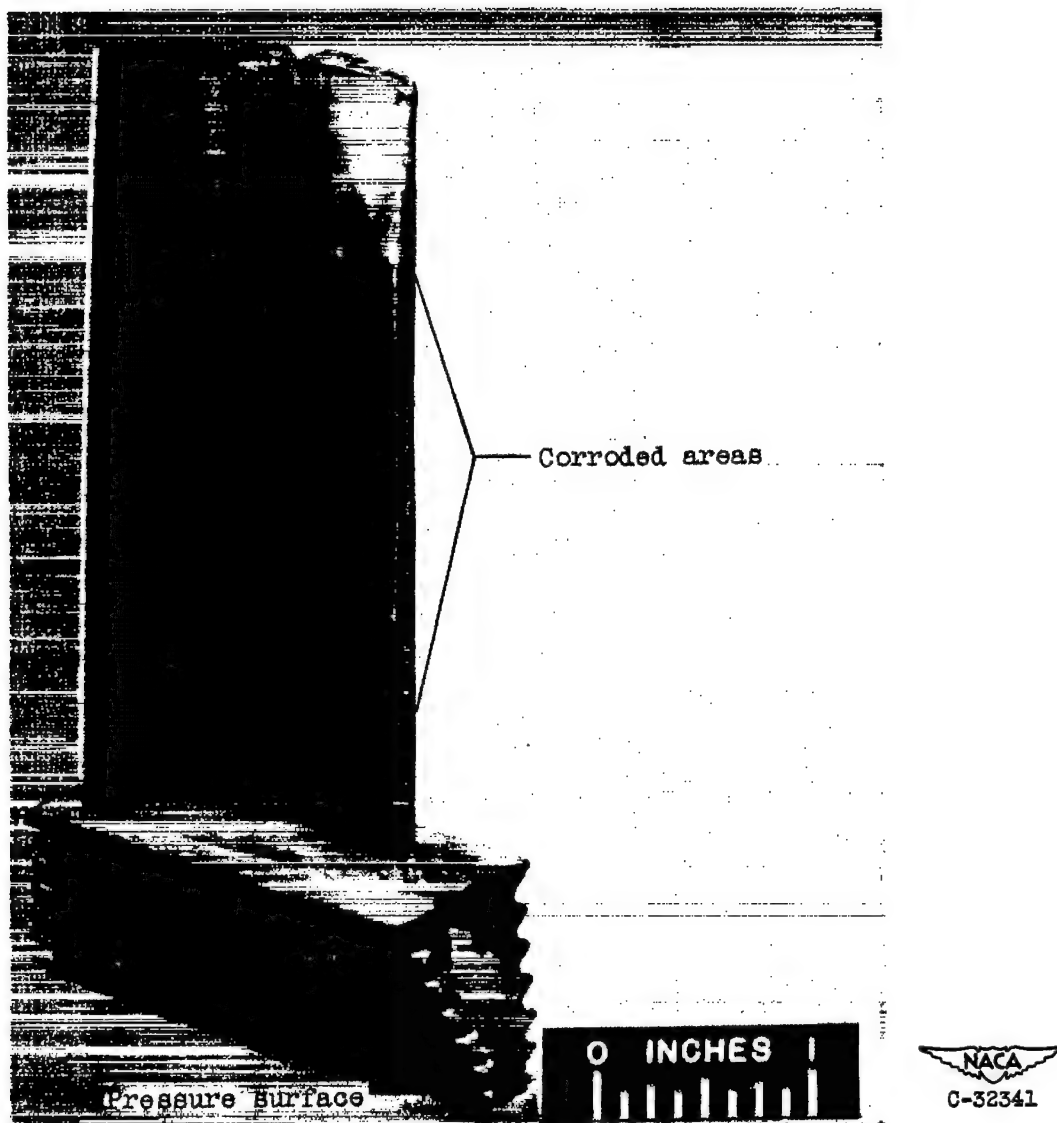
Blades 6, 8, 9, 11, 12, 14, and 15 were operated at rated test conditions for periods of time ranging from about 11.5 hours to as much as 25 hours before the coatings were considered failures. The failures of the nickel coatings were all similar, that is, the nickel began to blister and chip away from the leading- and trailing-edge regions of the blades as shown in figure 5(a). As operation of the blades was continued, corrosion of the parent metal in the leading and trailing edges occurred and the nickel coating also began to fail in the midchord region of the blade. The coatings generally began to fail first in the tip region of the blade after about 11 to 15 hours of rated engine speed operation. Temperature and centrifugal force are both factors in the breakdown of the coating. Failure usually progressed rapidly along the leading edge of the blade, where erosion also seemed to be a factor in removal of the coating. A blade that exhibited extensive erosion and corrosion at the leading edge is shown in figure 5(b), which is a photograph of blade 6 at the completion of 44 hours at rated test conditions. The failure of the coating along the trailing edge was generally less extensive than that at the leading edge, probably because the scouring action of the combustion gases is not so great in this region. Also, trailing-edge temperatures are somewhat lower than those at the leading edge. The temperature level of the blade material influences the life of the nickel coating; failure of the coating in the cooler midchord region was much more infrequent than at the leading and trailing edges (see fig. 2). Frequently, no evidence of failure was observed in the midchord region. The lower temperature apparently enables the nickel to adhere and provide the necessary corrosion resistance.

(a) Blade 12 after 55.3 hours at rated test conditions with coolant-flow ratio of 0.03 to 0.048. Coating completely eroded away at leading edge and blistered and flaked in scattered areas over entire blade.

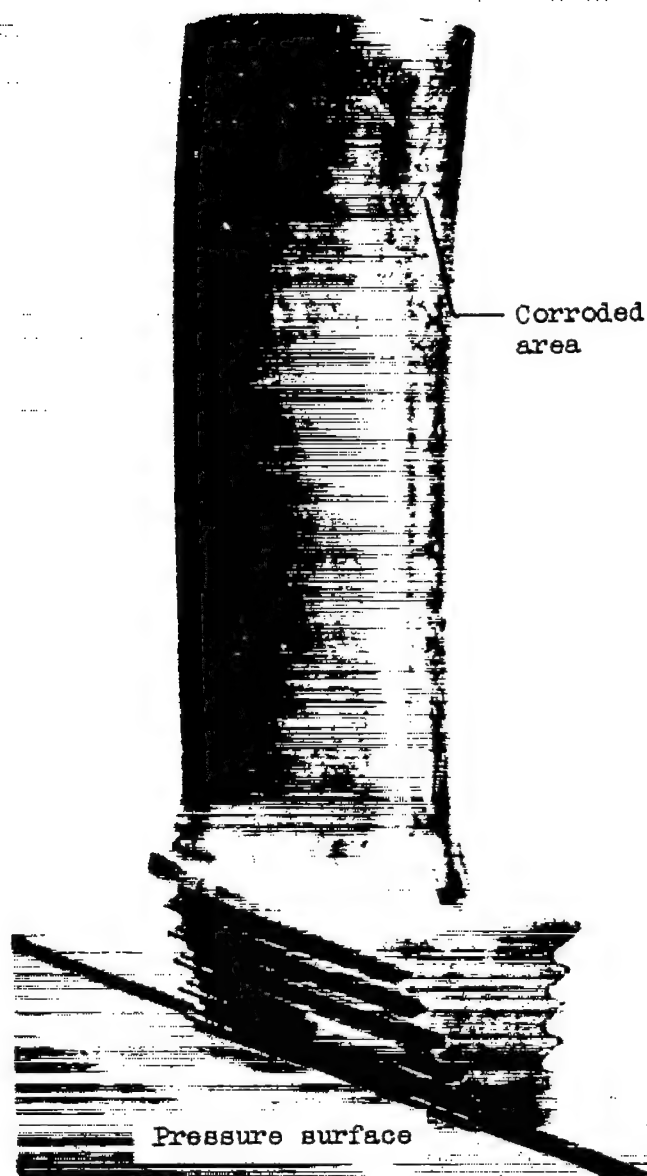
(b) Blade 6 after 44 hours at rated test conditions with coolant-flow ratio of 0.048. Coating chipped and eroded on leading edge and eroded along trailing edge. Leading edge corroded near tip.

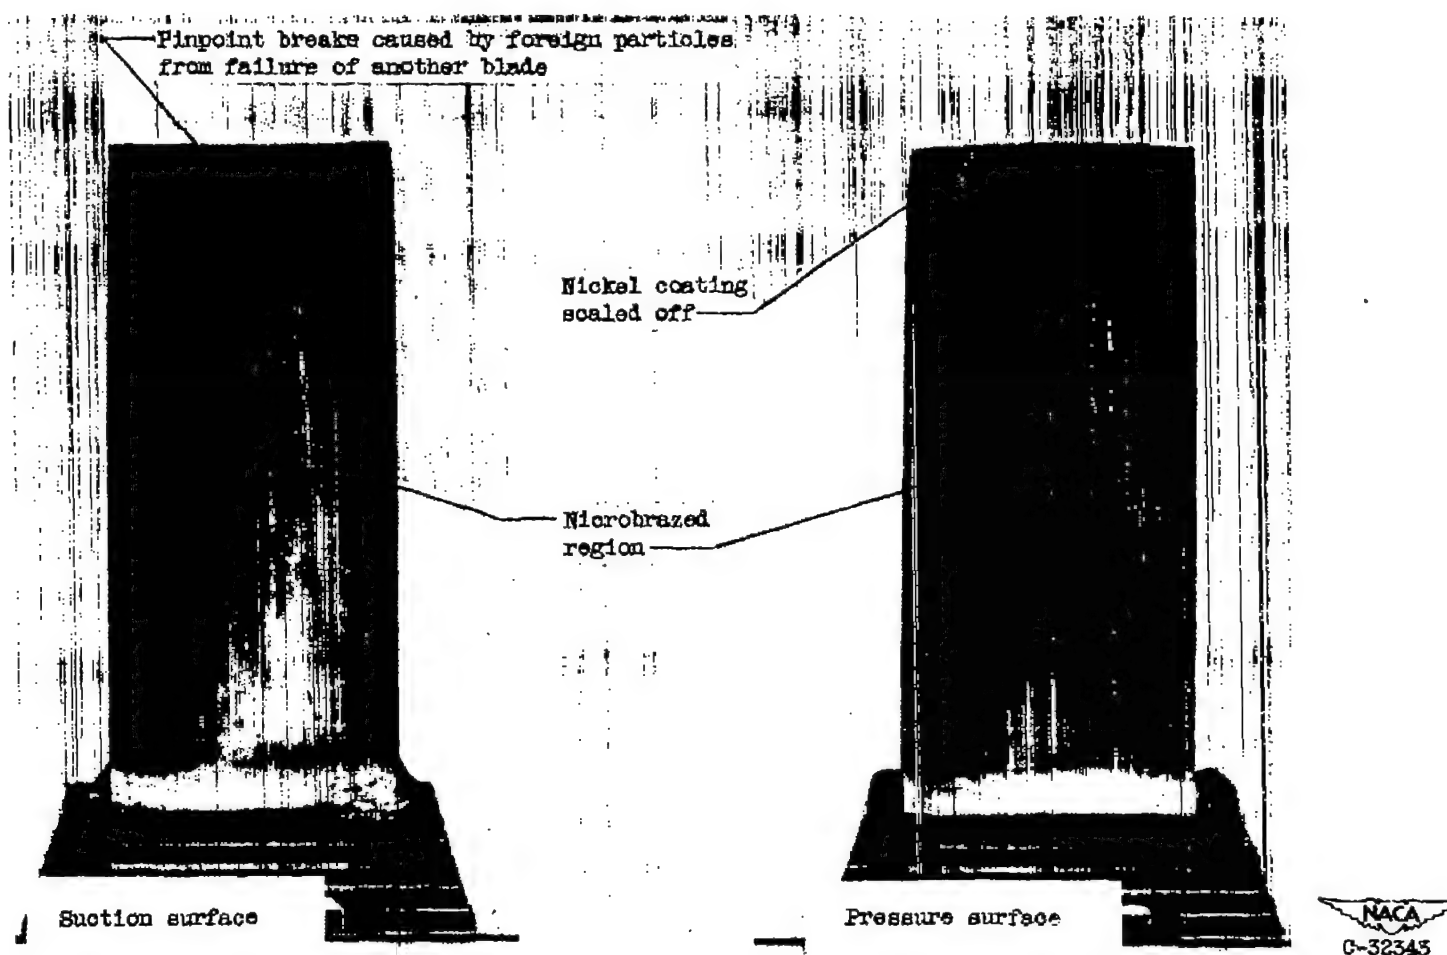
Figure 6. - Nickel-coated blade 20 with Microbraz along leading edge. Blade after 100 hours at rated test conditions with coolant-flow ratio of 0.048. Leading edge and midchord region in excellent condition.

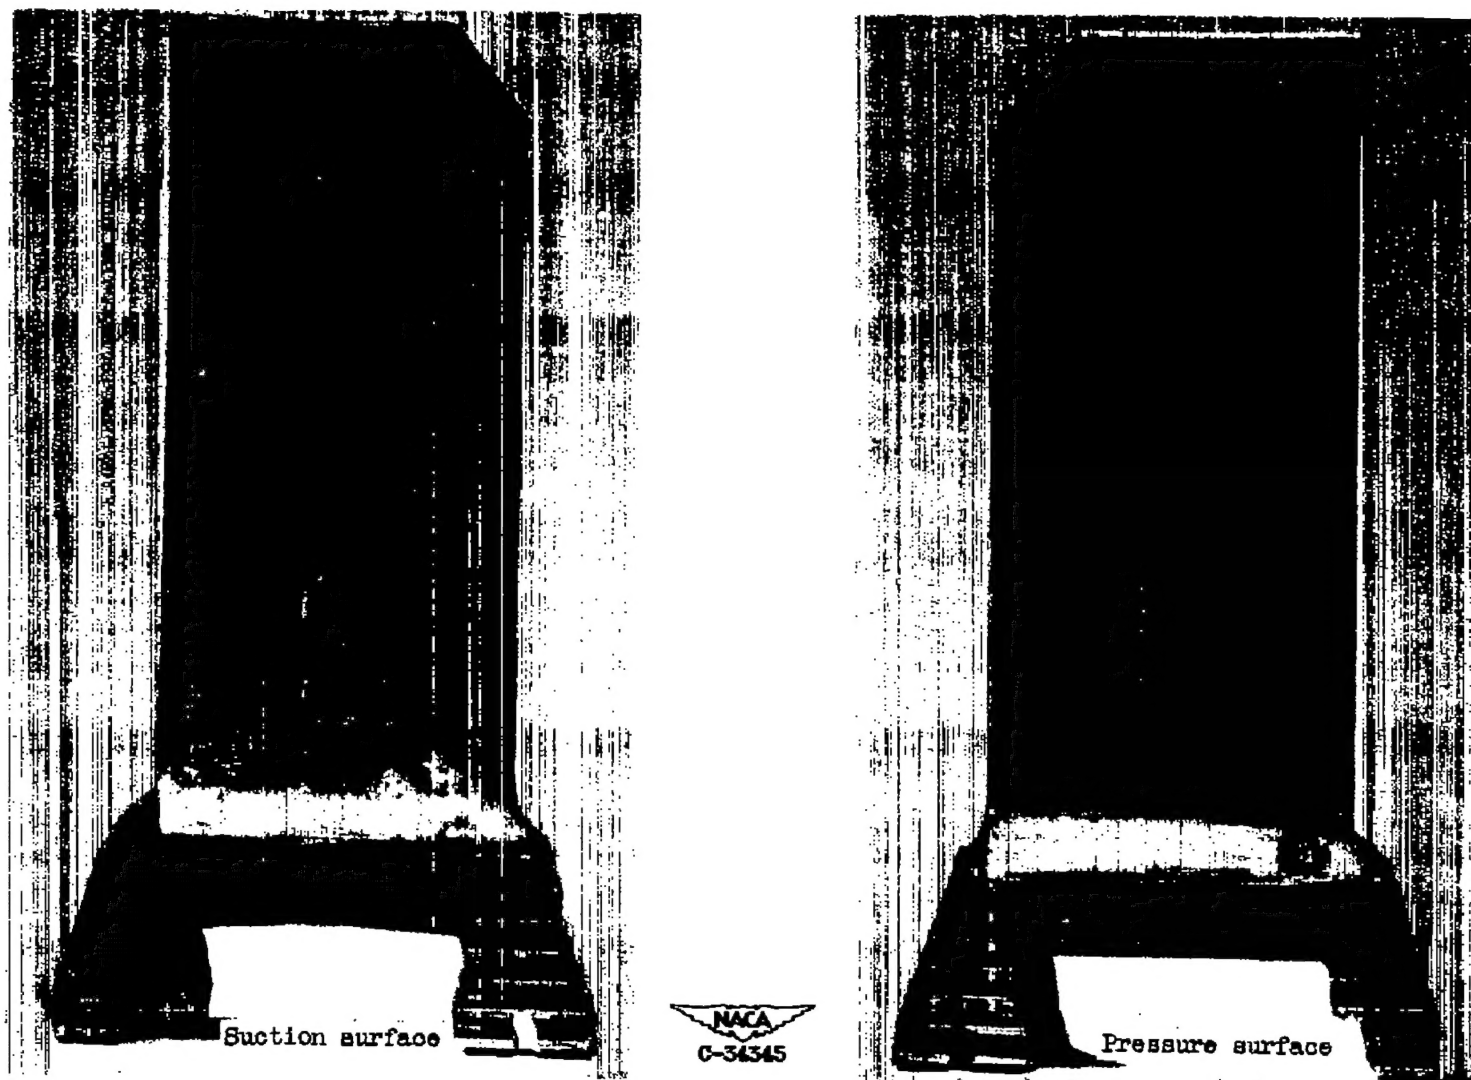
(b) Blade after 100 hours at rated test conditions with coolant-flow ratio of 0.048. Surfaces in excellent condition. Previously damaged areas shown on figure 7(a) indistinguishable from adjoining surfaces.

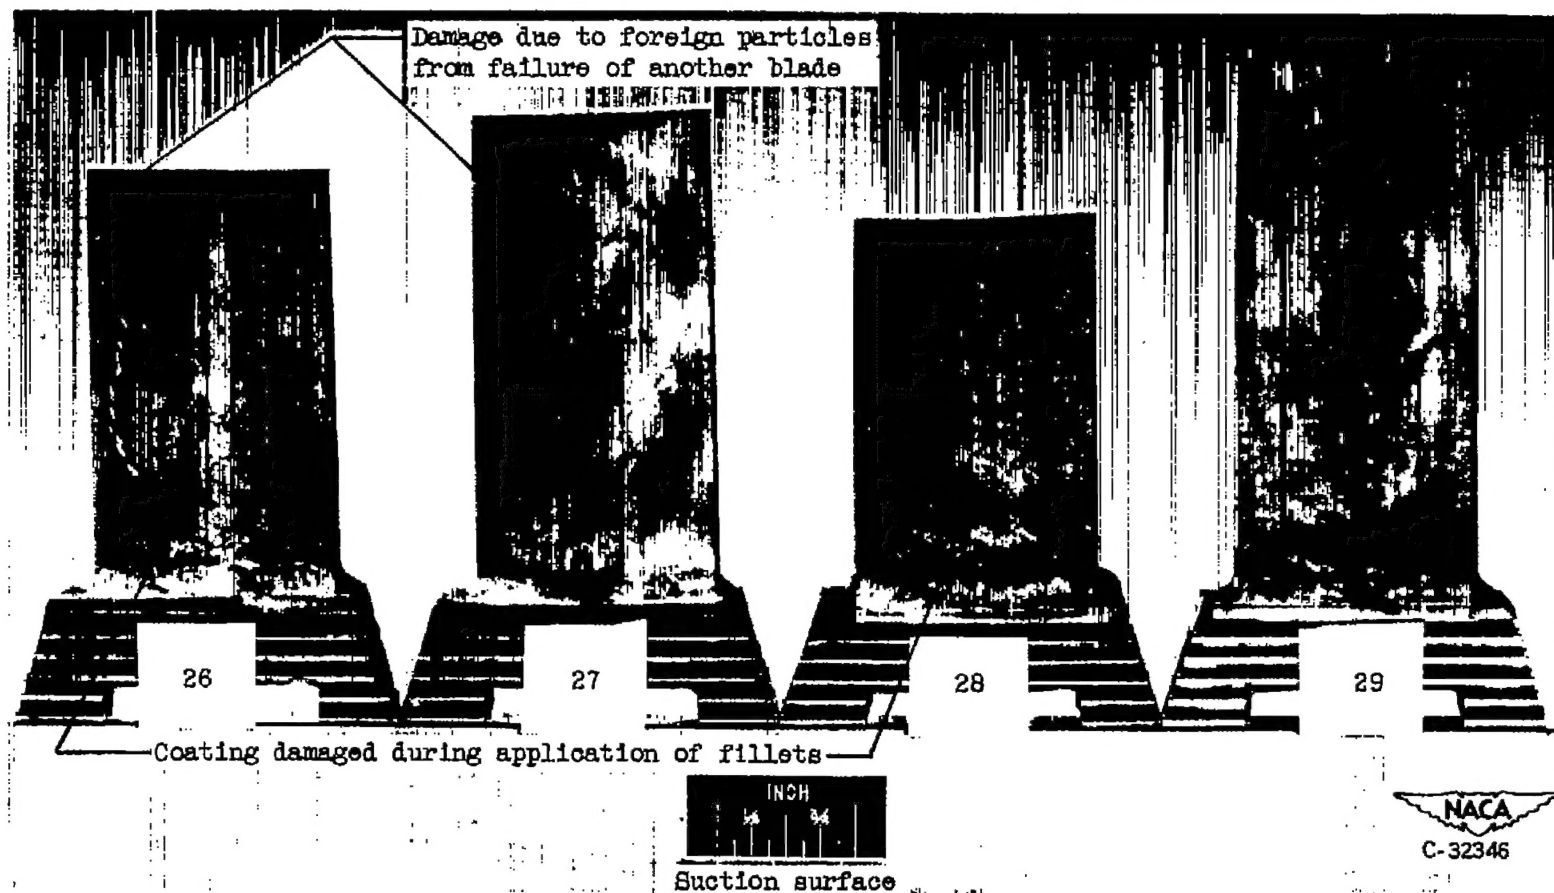
Figure 8(a) shows the suction surfaces of blades 26, 27, and 28 early in the investigation and of blade 29 prior to operation. Figure 8(b) shows both the pressure and suction surfaces of the blades at the completion of the investigation. Comparison of the suction surfaces shown in figures 8(a) and 8(b) indicates that there was little change in the condition of the coating on the blades, even though the blades of figure 8(b) have about 100 hours more operating time than in figure 8(a). With one exception, the entire surface of each blade including the leading- and trailing-edge regions, which were the first to exhibit failures on the ceramic and nickel coatings, was in excellent condition at the completion of the tests. Surface scratches and abrasions showed no tendency to progress and no corrosion developed in them as the investigation continued. The tip regions of blades 26 and 27 were damaged when struck by fragments of another blade, but the aluminized coatings continued to protect the surrounding areas. No corrosion was evident except on blade 27, where the metal was actually torn and the bare steel was exposed to the action of the gases.

(a) Blades during early stages of endurance running with coolant-flow ratio of 0.03. Time on blades 26 and 27, 23.8 hours; on blade 28, 18.1 hours; on blade 29, no time. Surfaces in excellent condition.
